Restoration of Bervie Jubilee Bridge

Restoration and Corrosion Management of an Historic Bridge in Scotland

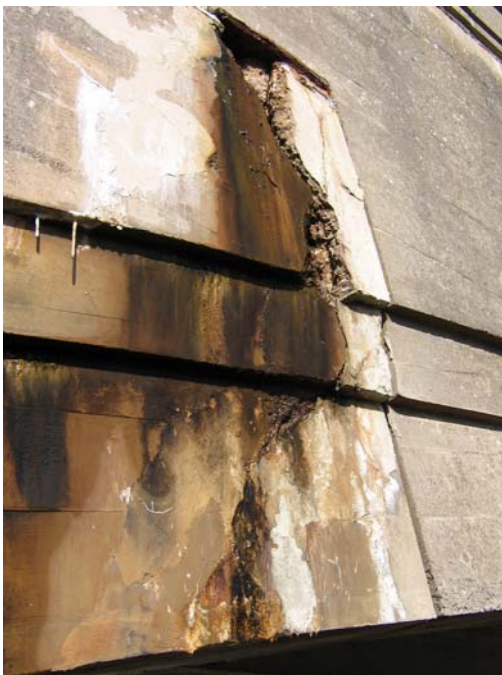
The worst problems were focused on the soffits of the beams arising from the venturi effects of the circulating marine environment under the bridge and through the leakage of chloride-entrained water through the half joints (see Plates 4 and 5 below).

The nature of the corrosion problems were typical for chloride accelerated attack typified by the pitting of the surface of the reinforcement steel closest to the point of ingress of the environment.

Plate 4: Worst case expansion joint condition found during inspection

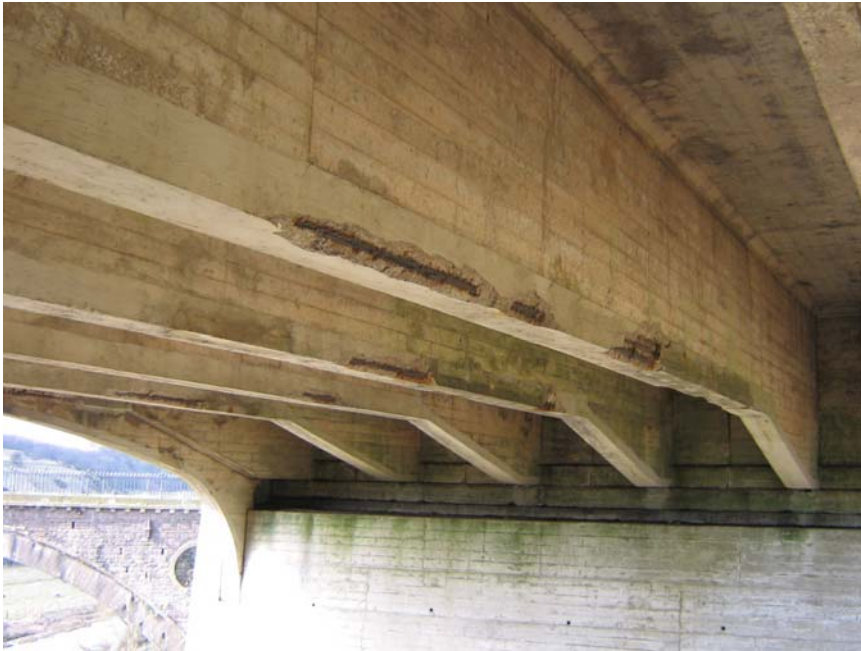
Plate 5: View of support beam disrepair of soffits and arrises

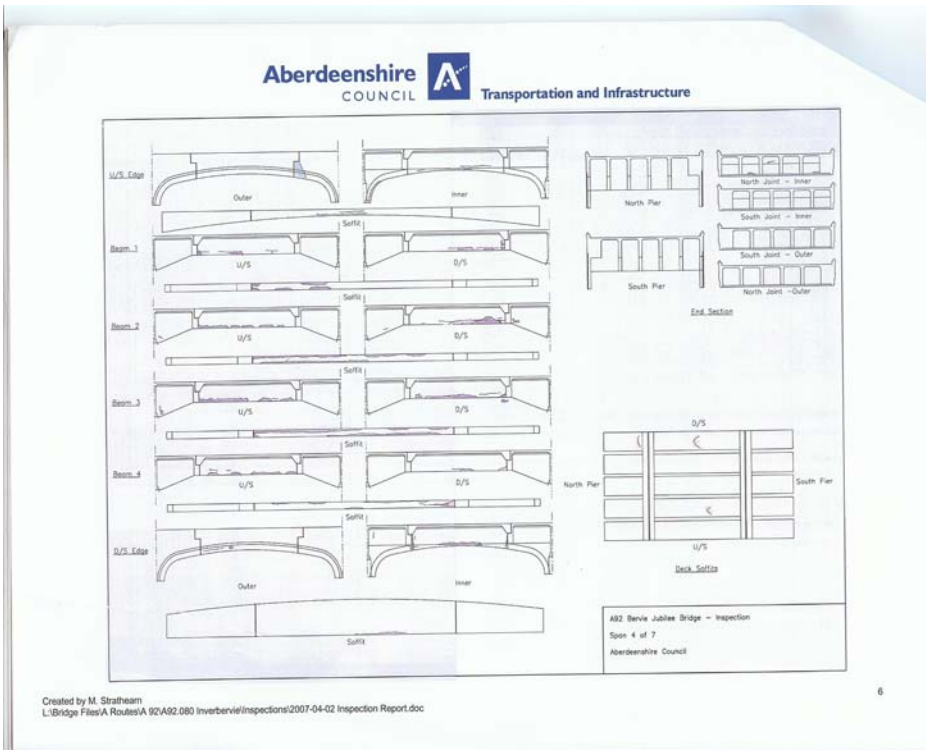
The Client undertook a major underbridge Principal Inspection visual survey marking all repairs necessary to be done (an extract is shown in Plate 6) and concluded that if the corrosion was left unchecked then this would lead eventually to a reduction in strength and the contravening of European legislation

for full vehicle loading that in turn would have a debilitating effect on local trade and to the economy of the area in general.

Plate 6: Extract from Principal Inspection of bridge support beams

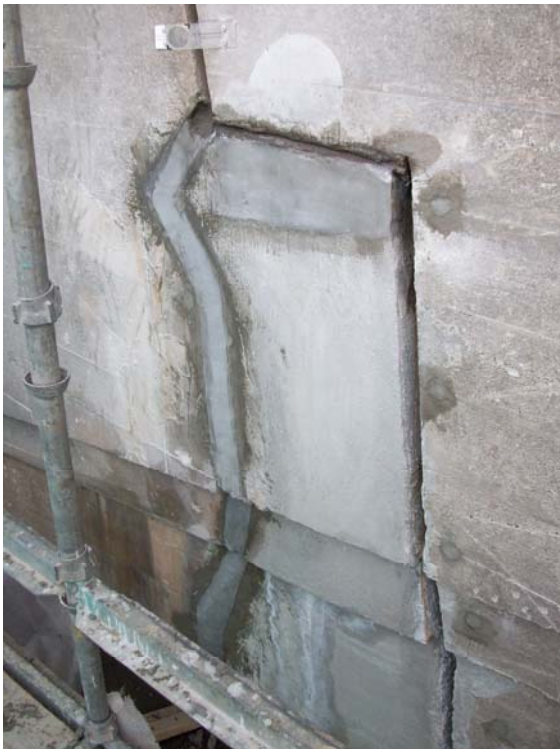
Plate 9: Repair to the expansion joints varied in complexity with this joint compared to the initial damage depicted in Plate 4.

The concrete repairs were undertaken in compliance with the EN 1504 standard for repair and protection of reinforced concrete structures that mirrors practices within the Concrete Repair Guide. Concrete removal was achieved generally by hydrodemolition of delaminated concrete only. Plate 9 below demonstrates the extensive repair needed to repair the damage to the half-joints of the bridge.

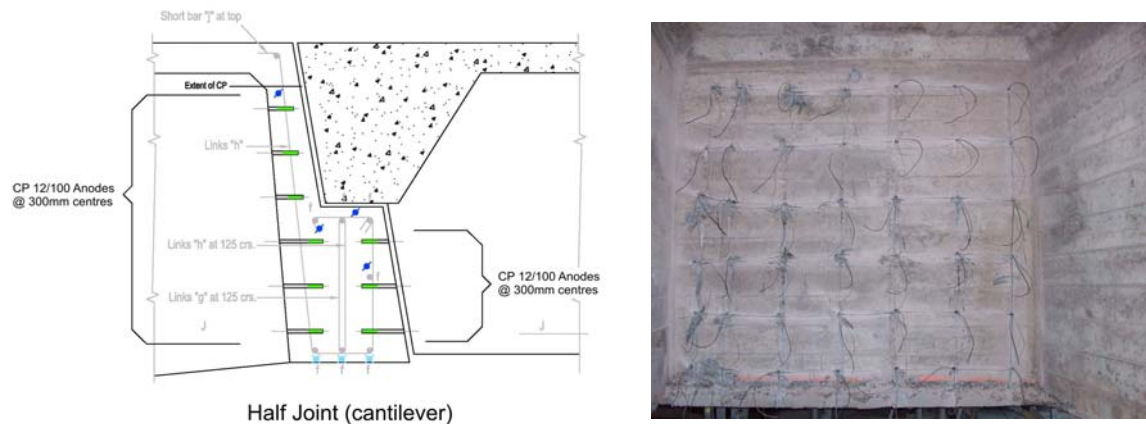
Plates 10 and 11 show cross-sectional details of anode positions within the half joints and compares this with a photograph of the installed anodes.

This led to the specific choice of the fluted or star-shaped conductive ceramic anode that provided the necessary higher currents needed to protect the 3-dimensional steel densities whilst minimizing the diameter of the drill hole. All anodes were installed as ½ inch diameter with a standardized 4 inch length to provide the necessary current output with variable depth of drilling to target shallow and deep steel configurations.

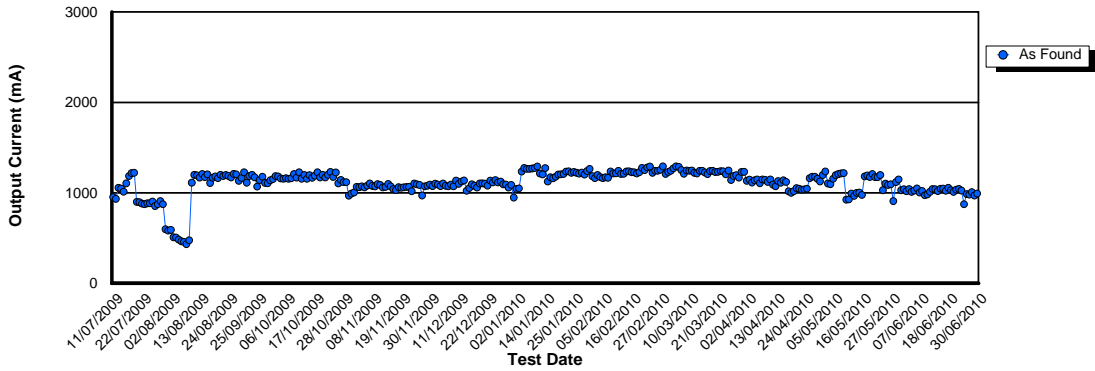
Daily As Found Currents

Note in this zone that the power is supplied in constant voltage mode and the output current varies with environmental demand.

The current supplied has been consistently less than 50% of capacity for year 1 when the demand is at its highest and providing consistent protection.

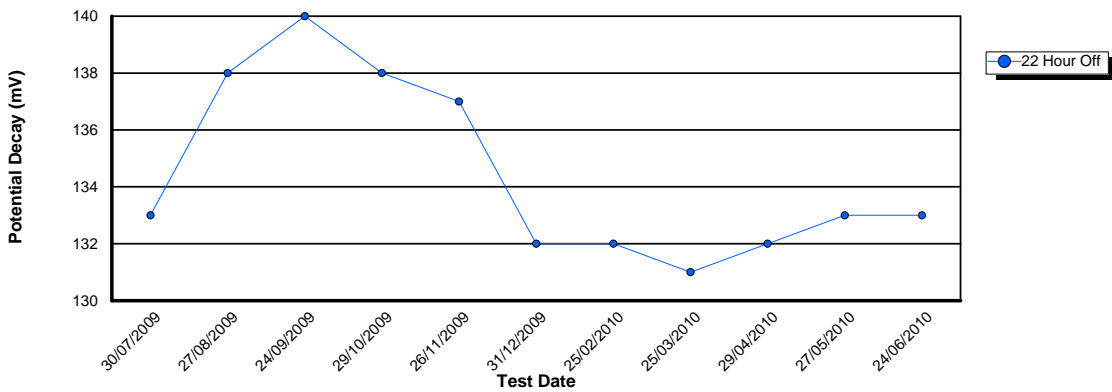
Electrode Potential Decay

The data demonstrates a consistent achievement of 100mV potential decay and a shift of end of decay potential towards a less active potential (-237mVCSE towards -185mVCSE) that would represent a move from medium to low risk if left unenergized. This situation is not repeated in all locations as the ability to repassivate the steel will vary over the structure.

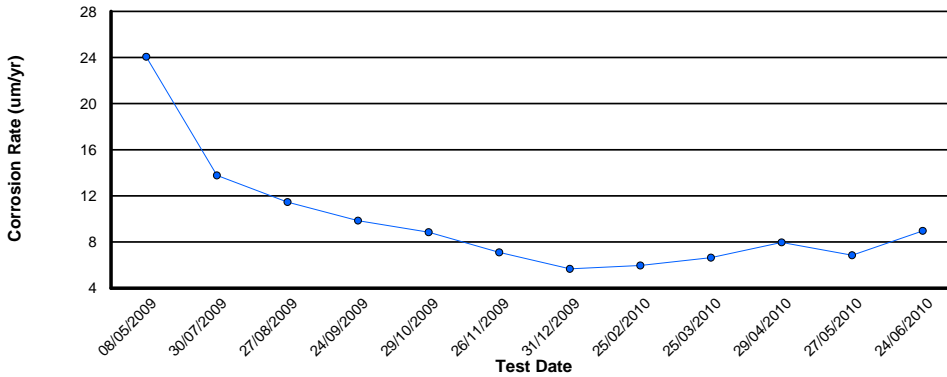
Corrosion Rate Values

The data demonstrate that the standards are being met with corrosion rate also reducing.
