LONGFELLOW TOWERS 1 AND 4

Boston, MA

Abstract

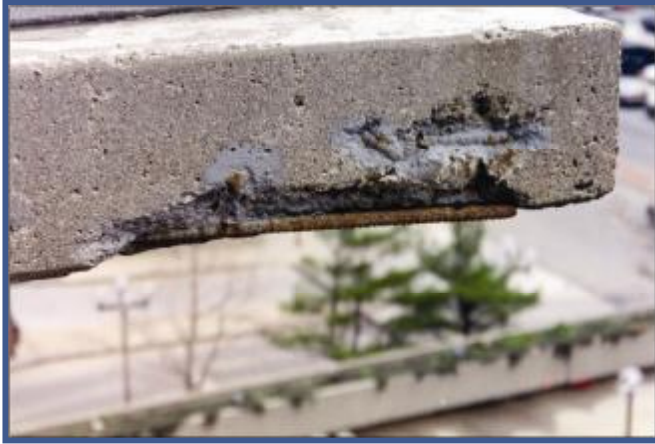
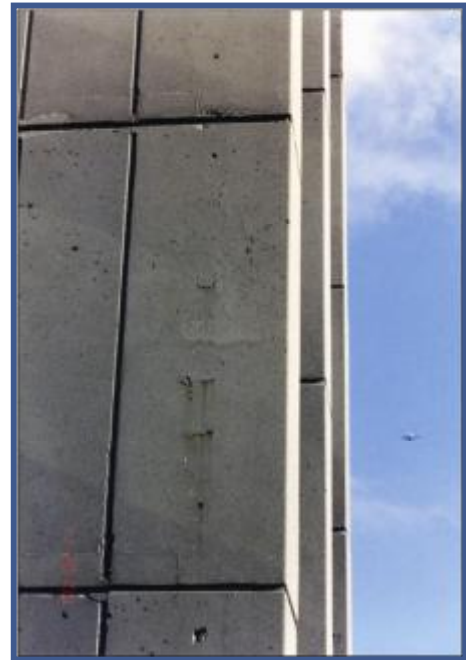
Inspections conducted in 1997 identified numerous areas of spalls. Despite attempts to repair the spalls, their number continued to grow over time. More recently, sealant joints at the sliding glass doors, ac units and windows were failing and allowing water to leak into the apartments.

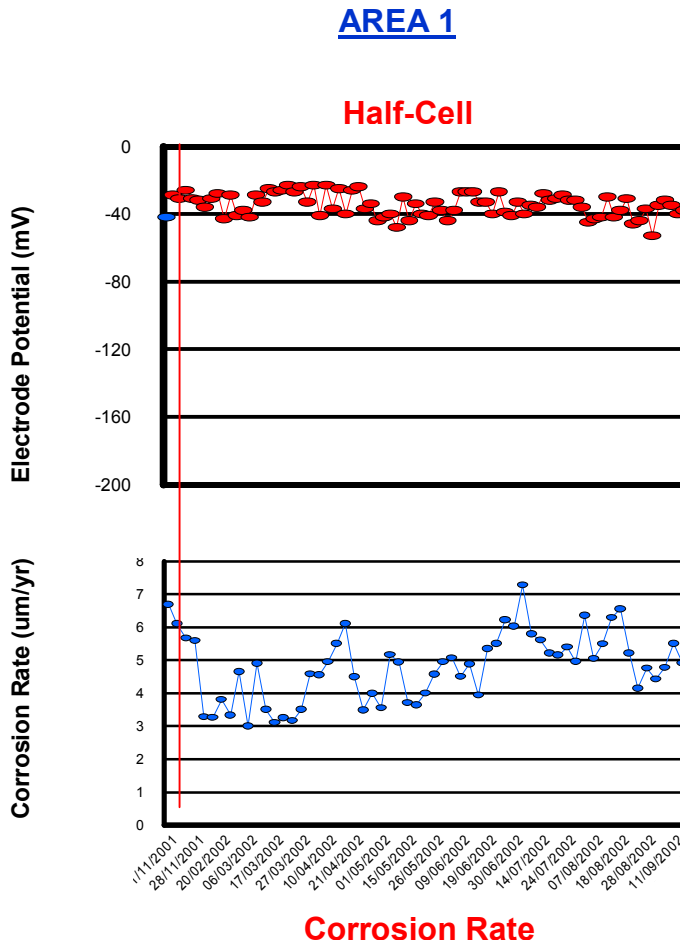
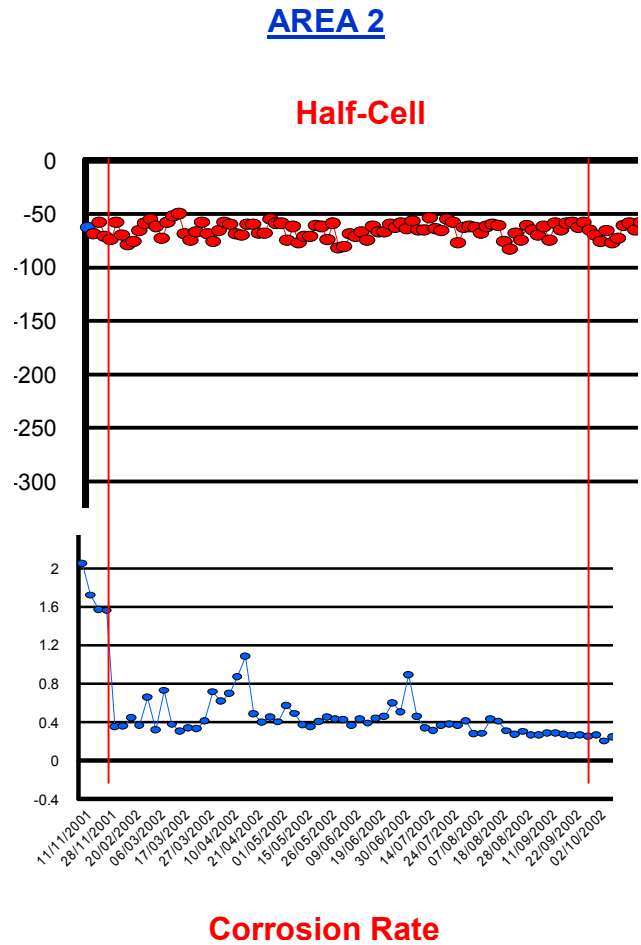
1. While half-cell potentials indicate low probability of corrosion in both treated areas, the corrosion rate at area 1 is actually moderate.
2. The corrosion rate at area 1 behaves somewhat erratically throughout the test period. Initially there appears to be a benefit; however, as time goes on the rate fluctuates and tends back toward the initial corrosion rate.
3. The corrosion rate at area 2 starts at a somewhat passive condition; however, there is little fluctuation throughout the test period and the trend seems to be an overall decrease in corrosion activity.

1. A leveling mortar would not be used.
2. Voids and honeycombs greater than ¼" in diameter would be filled prior to coating.
3. No primer was necessary for the elastomeric coating.

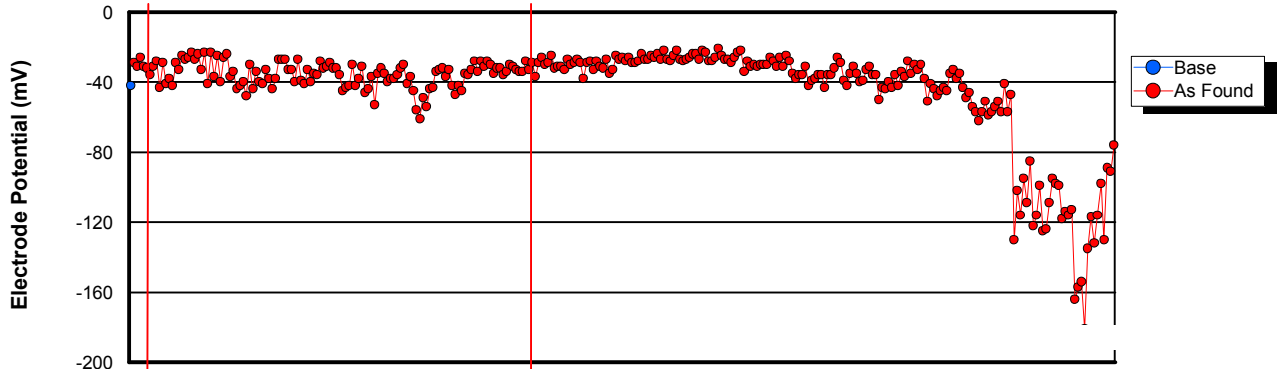
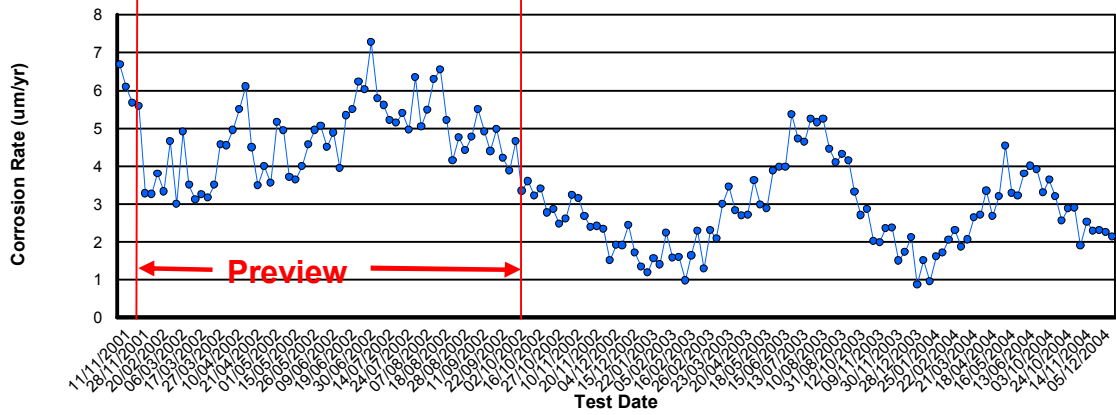
AREA 1

3. Area 1 corrosion rate continues to fluctuate. In fact it seems to be mirroring the time of the year in that rates increase during the hot/humid summer months and decrease during the cold/drier winter months.

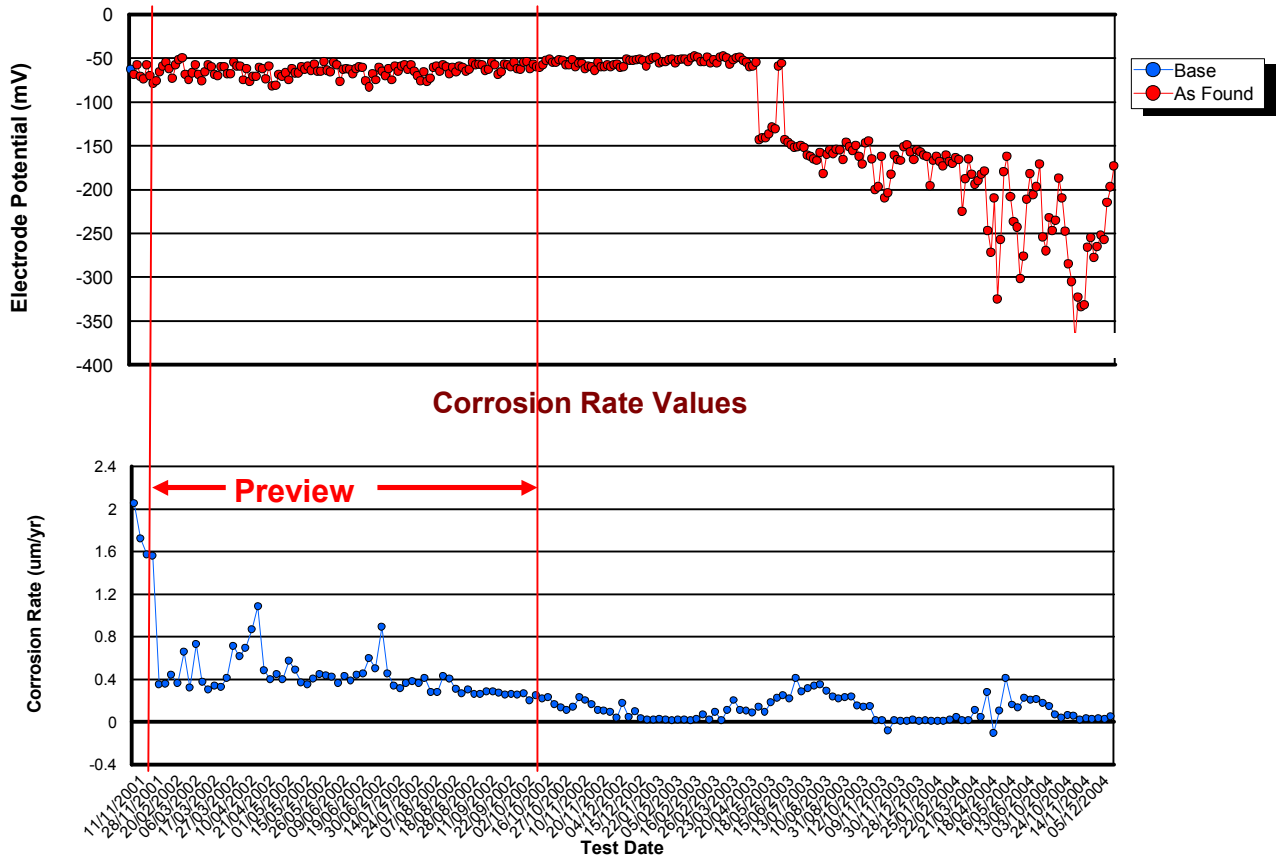
AREA 2

4. Area 2 corrosion rate has little fluctuation and continues to be passive. This is particularly significant in light of the half-cell potential readings and underscores the importance of not relying solely on half-cell potential since it is only an indicator of corrosion and not a measurement of actual corrosion.
