15th Asian-Pacific Corrosion Control Conference
October 18 to 21, 2009 | Makati City, Philippines

Corrosion Management of Reinforced Concrete Structures
– The Environmentally-Responsible Decision

Graeme Jones
Managing Director, Structural Healthcare Limited, UK

Case Study: Mayorhold multi-storey car park, Northampton, UK

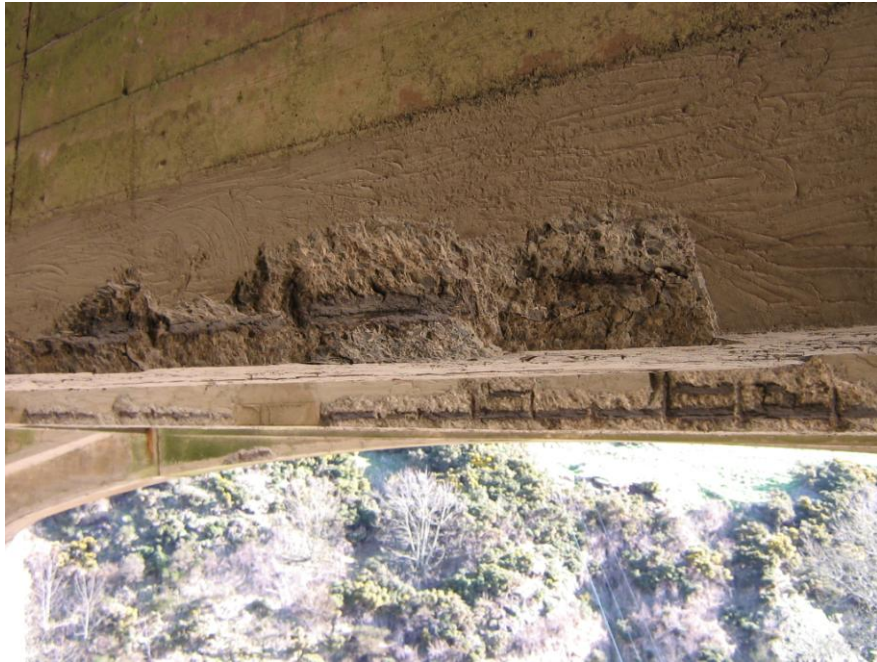
Figure 1: Bridge structure in Scotland showing localised spalling due to chloride contamination; concrete would have fallen some 30m to the ground creating structural, economic and health & safety concerns.

In Europe the approach to the type of problem shown in Figure 1 is now well documented in EN 1504-9 ⁽⁴⁾ where repair, strengthening and corrosion management are integrated into a single harmonised standard. In the USA (and used throughout the world) there is also The Concrete Repair Manual ⁽¹⁴⁾ to lead the engineer to a sensible strategy for solving the problems.

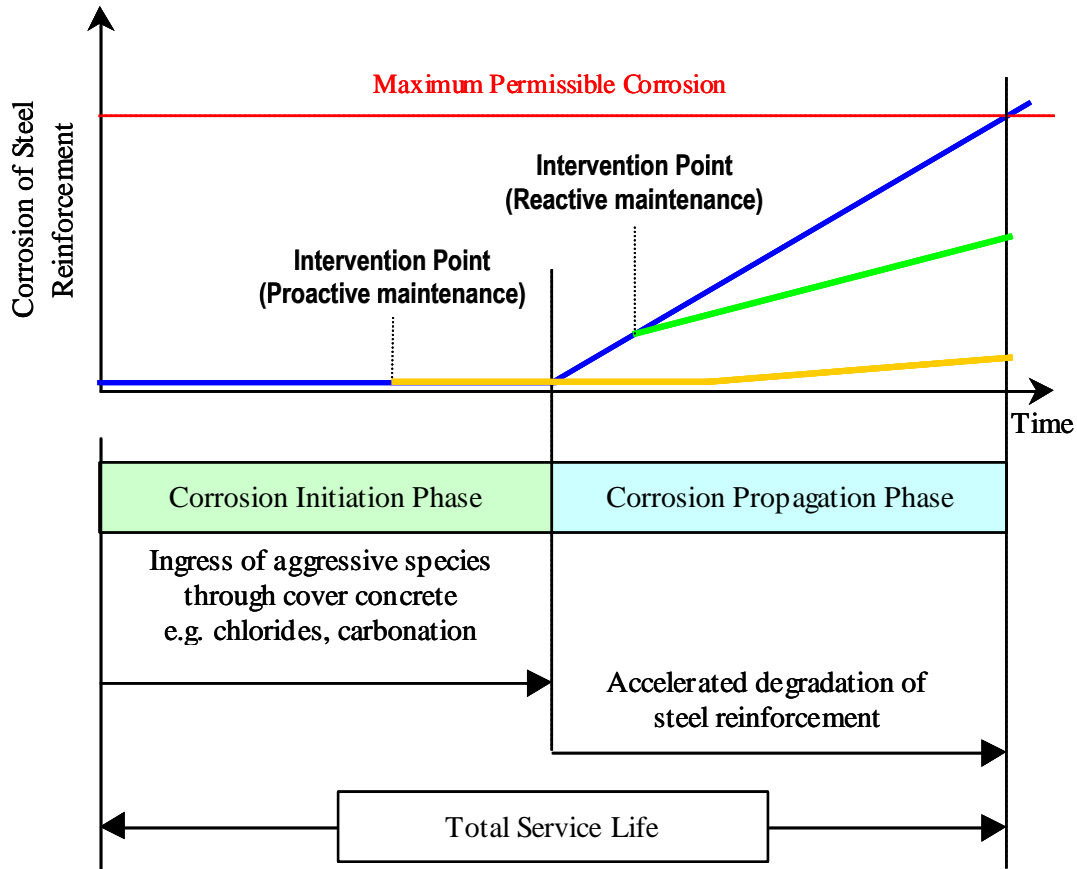
In this schematic the upper sloped line represents no intervention and the service life is defined by the maximum permissible corrosion before degradation leads to loss of structural integrity. This point will vary for structures in different environmental exposure conditions and in respect of design tolerances during construction, especially over-design of structural requirements.

Intervention during the corrosion initiation phase (that is, before there are visible signs of corrosion and its effect on the concrete cover) by proactive maintenance can often lead to significant service life extension as the point of reaching the maximum permissible corrosion limit is in itself extended in time significantly.

More often we see the intervention point represented by the reactive maintenance line where corrosion has propagated to some extent and probably lead to visible signs of degradation leading to the need to repair the structure and consider corrosion mitigation options as an add-on to that repair strategy.

Figure 2: Schematic representation of structure service life and the impact of timing of intervention to achieve a service life extension.

Figure 2 below demonstrates the effect of intervening in the corrosion process and the impact of timing on the extension to service life.

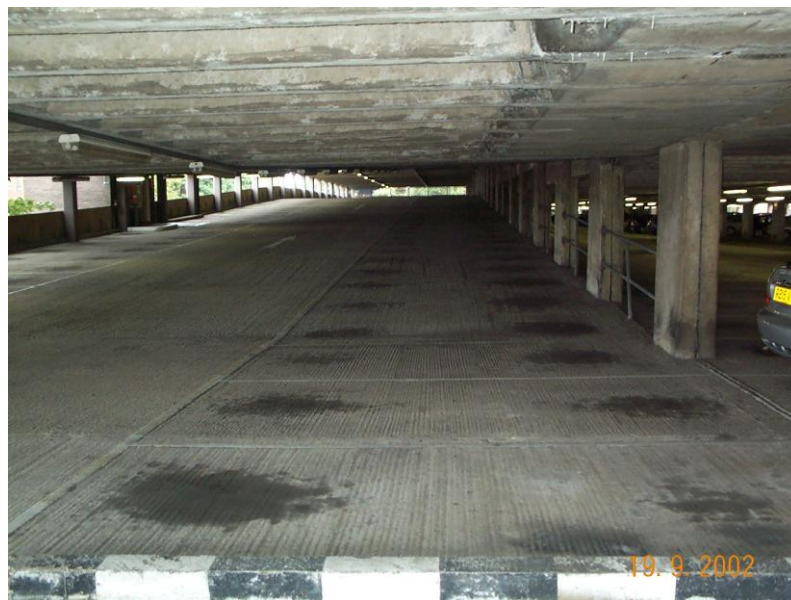
Figure 3: View of Car Park before rehabilitation program began

The structure is a trough slab construction and conventionally reinforced through deck and within support downstand beams. Light mesh reinforcement exists between downstand beams.

Expansion and day joints were the focal point for growth of the corrosion issues.

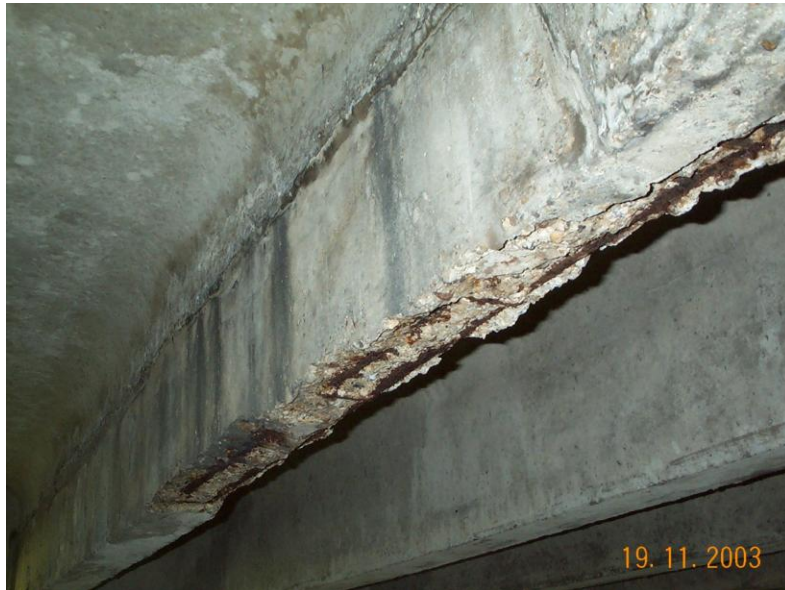
Figure 4: Typical damage to downstand beam arising from leaking chloride-contamination from deicing salts carried in by traffic and through expansion and dayjoints.

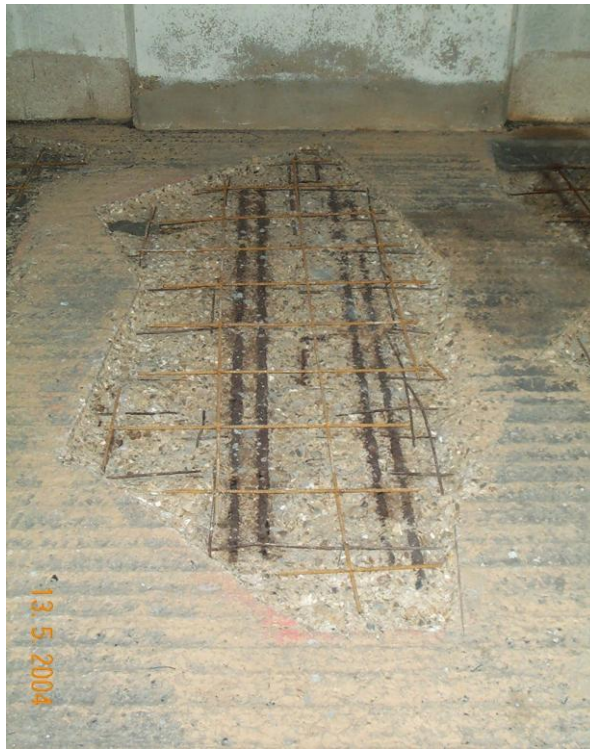
Figure 5: View of reinforcement steel layout and typical corrosion condition with 32mm bars above downstand beams and steel mesh overlaying and spanning to next beam.

However, the repair areas were observed to be emerging mainly from leaking expansion joints/day joints. The downstand beams associated with these areas were in more serious condition than other mid-span beams. There was also corrosion and spalling issues associated with reinforcement in the deck surface over the beams.

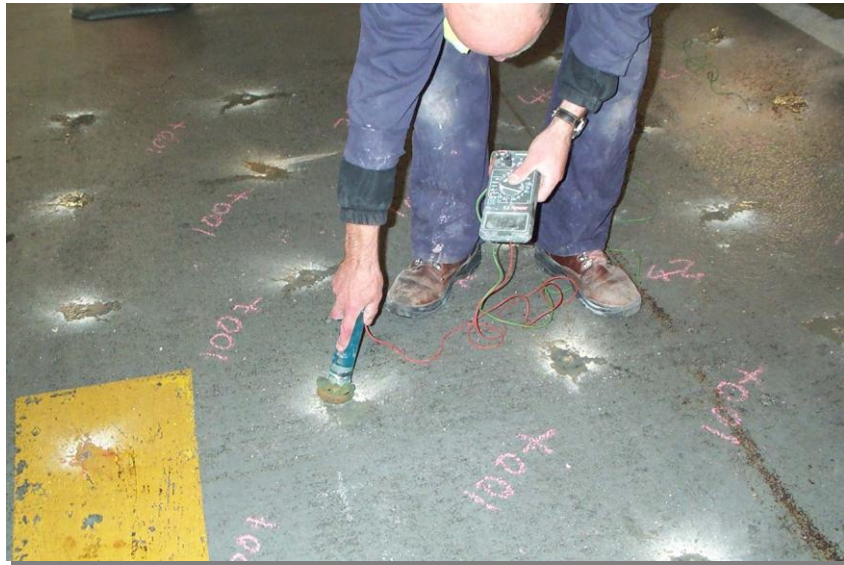
Figure 6: Half-cell testing of parking decks

In 1999, the first phase of investigation began on Levels B and C and revealed high chloride and corrosion to the reinforcement over a significant portion of these levels. This was repeated in 2003 and over a four year period it was determined that the problem was accelerating in the high chloride areas.

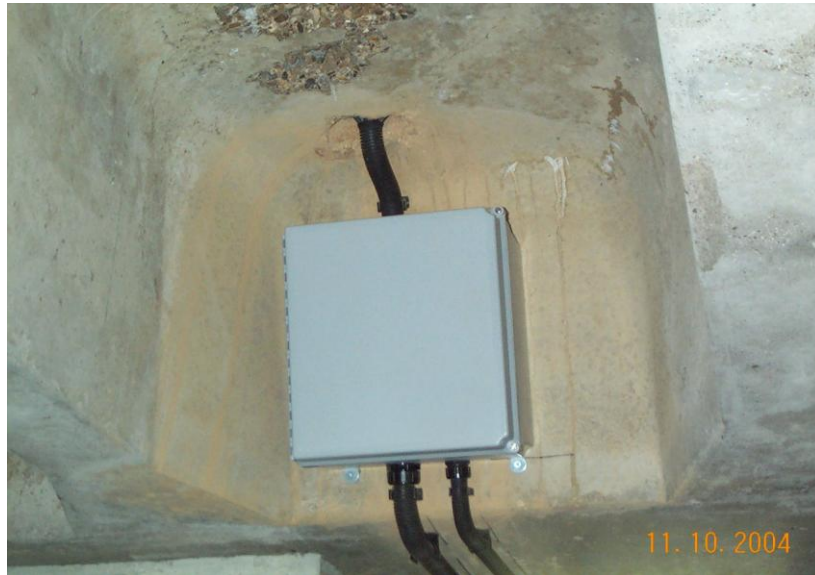
Figure 7: Control and monitoring electronics fitted neatly between downstand beams and protected against damage

The system installed integrates all corrosion mitigation choices in a single controllable network management system. Boxes containing specific electronics for ICCP power, control and monitoring as well as SACI and early detection monitoring were discreetly hidden within the trough ends.

A single network management access unit controls the whole installation and is conveniently sited in the parking management suite.
