Hi-TECH HERITAGE

One of central Manchester's historic landmarks, Arkwright House, has been subjected to a novel form of cathodic protection to prevent further corrosion of its structural steel frame. Graeme Jones, C-Probe Technologies Limited, Paul Lambert, Mott MacDonald and Peter Bolton with Michael Robinson of Richard Ellis St. Quintin* discuss some of the attributes of this radical approach to sustaining and improving the service life of a precious city asset.

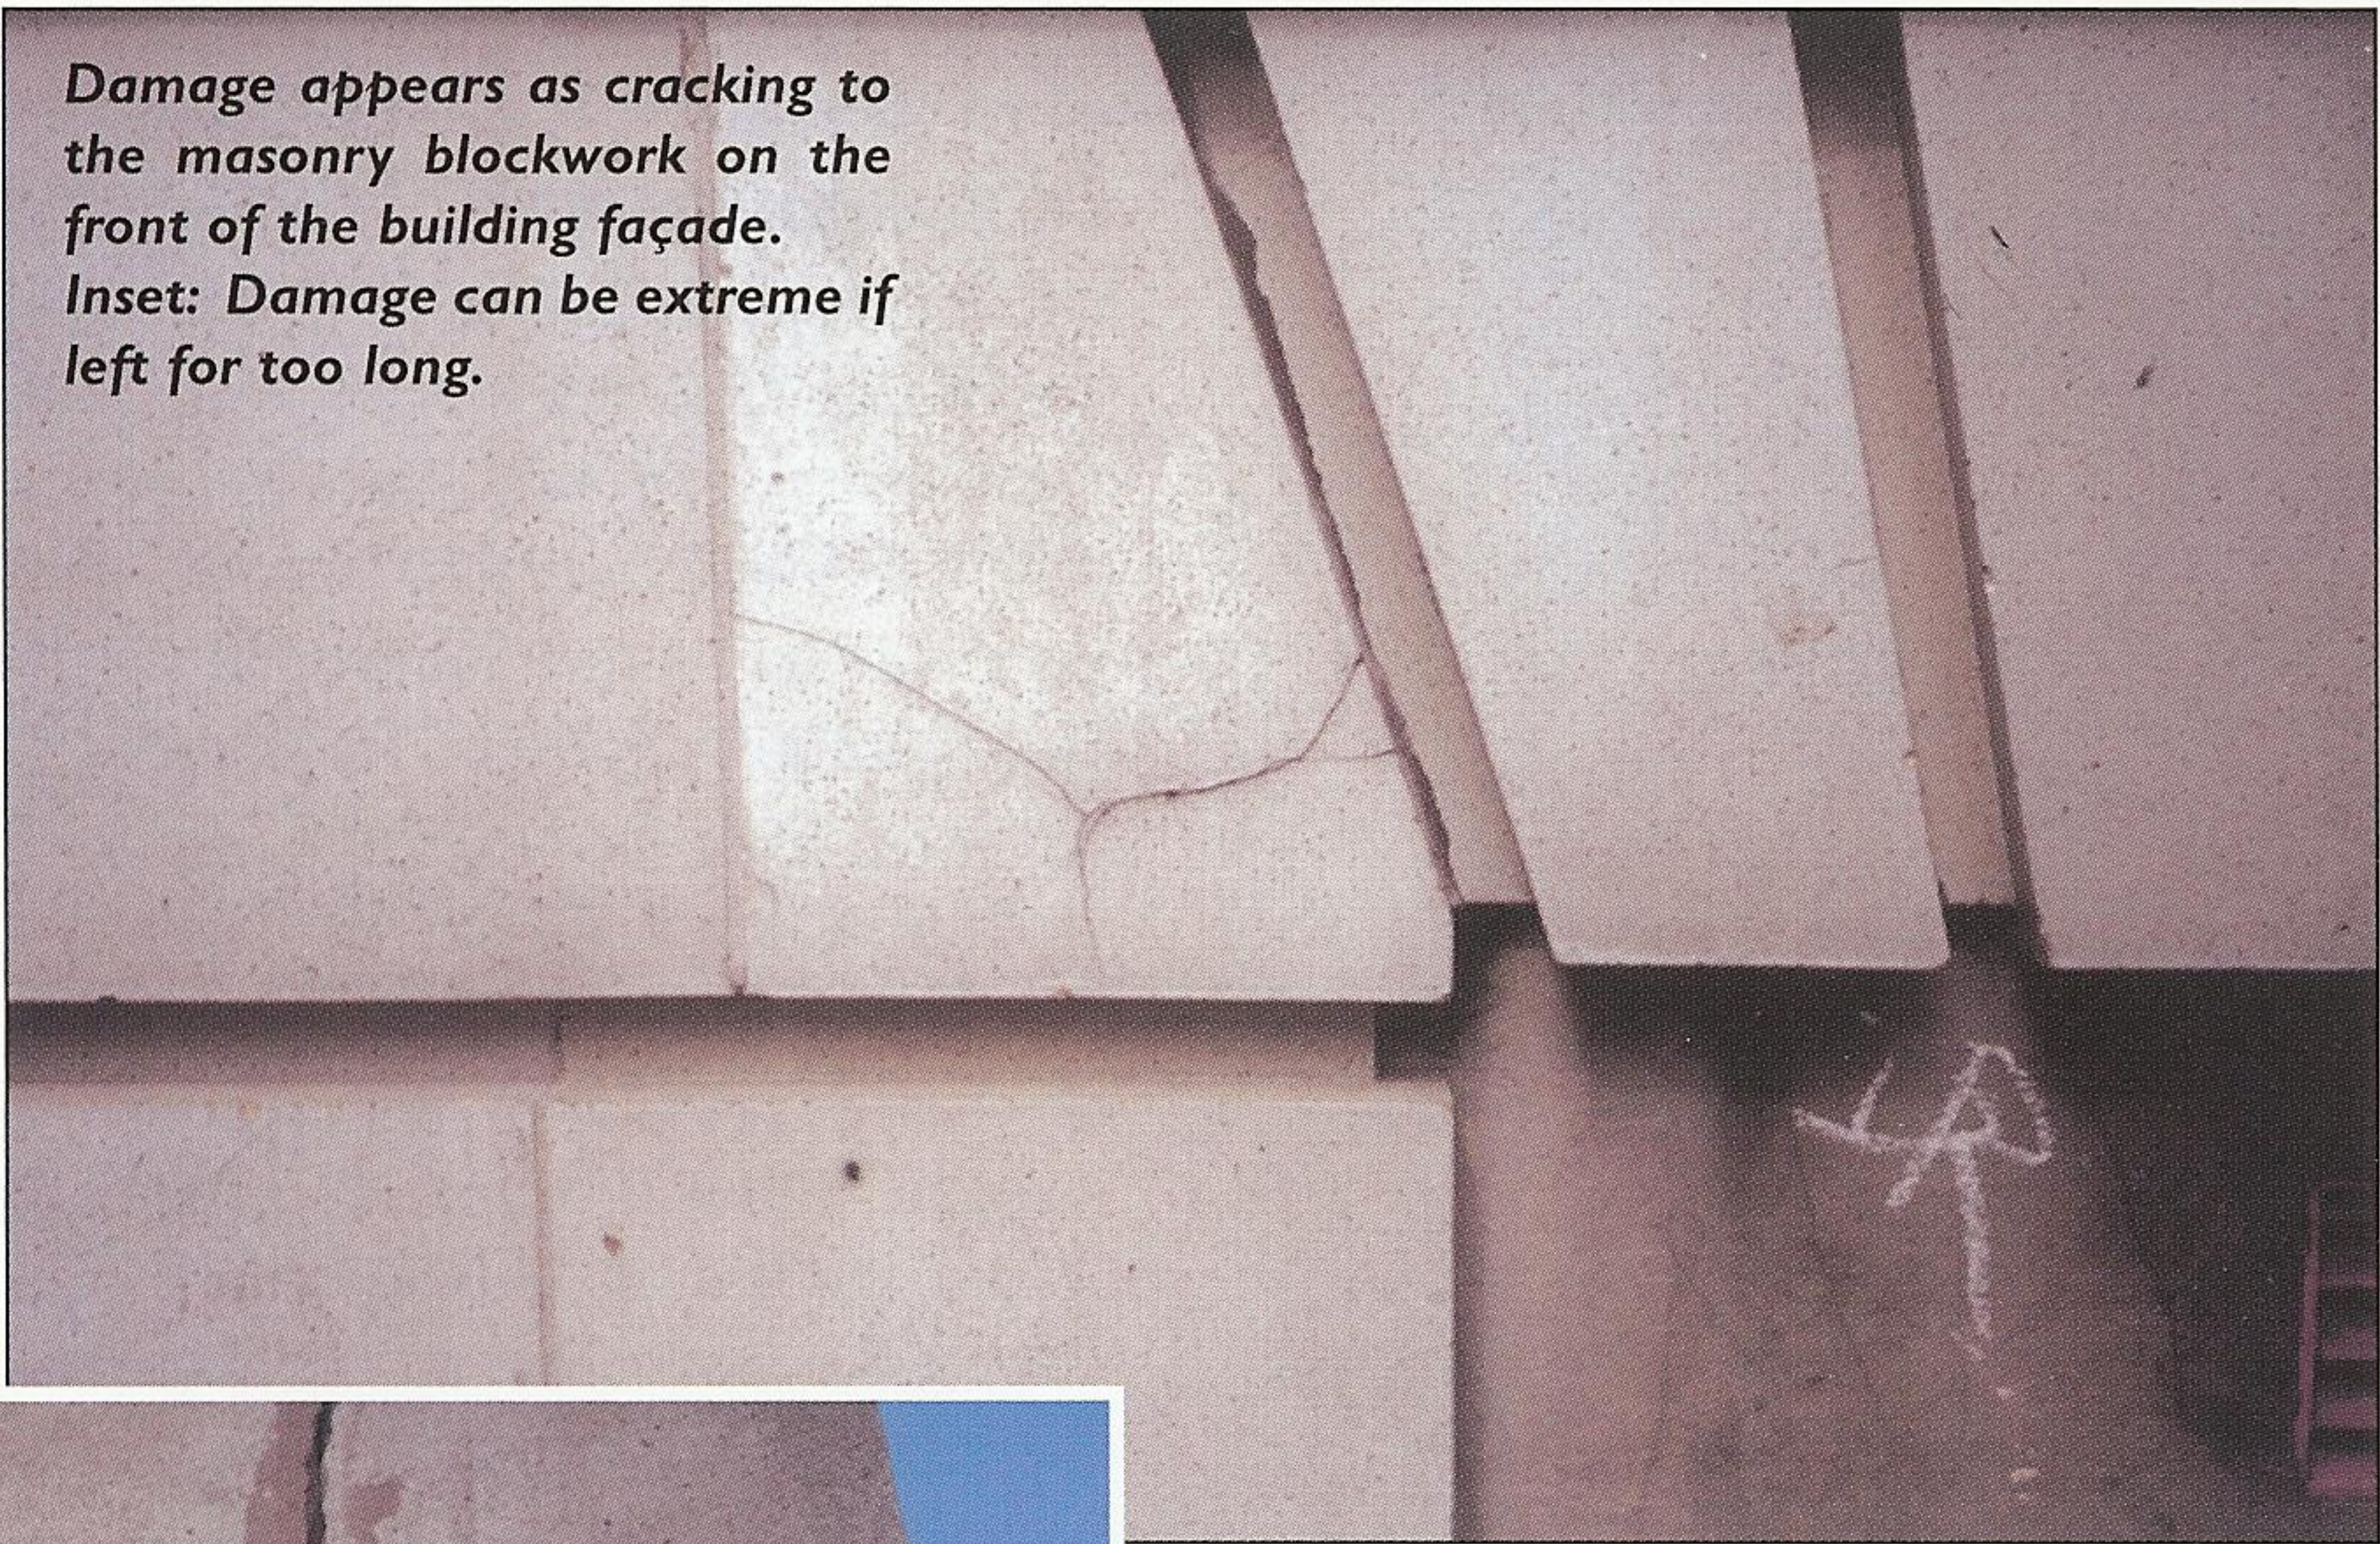
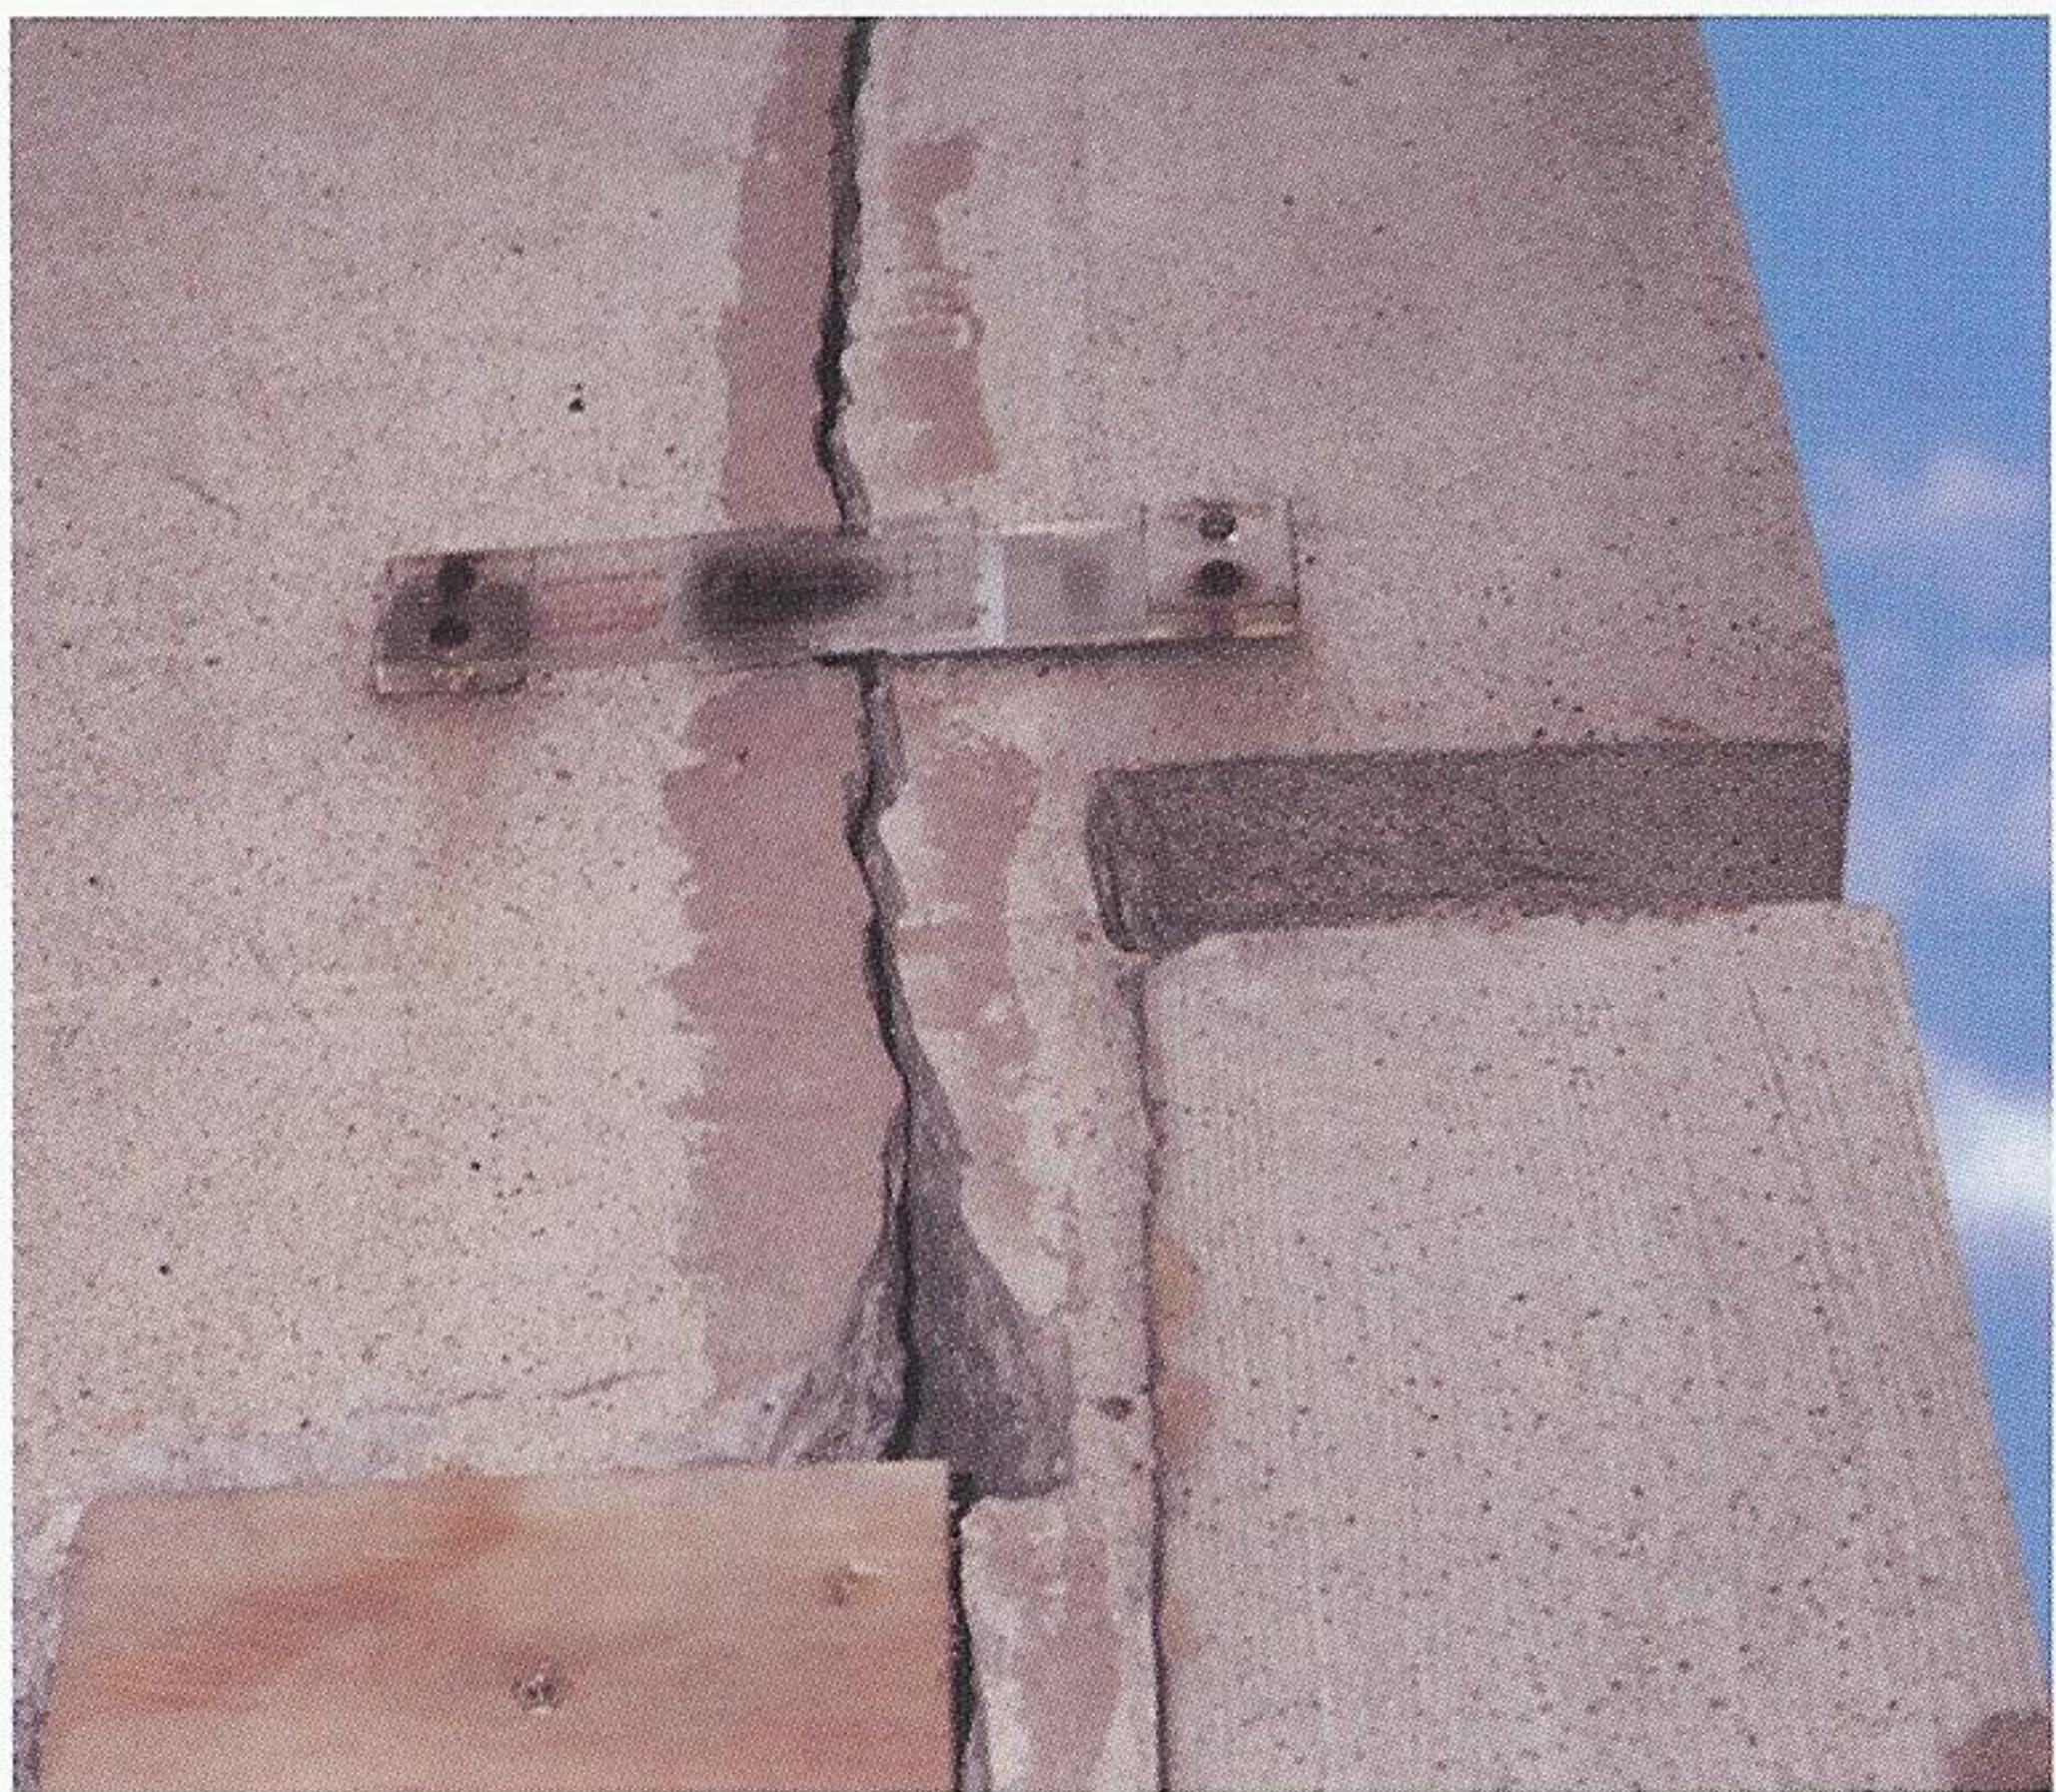
Damage appears as cracking to the masonry blockwork on the front of the building façade. Inset: Damage can be extreme if left for too long.

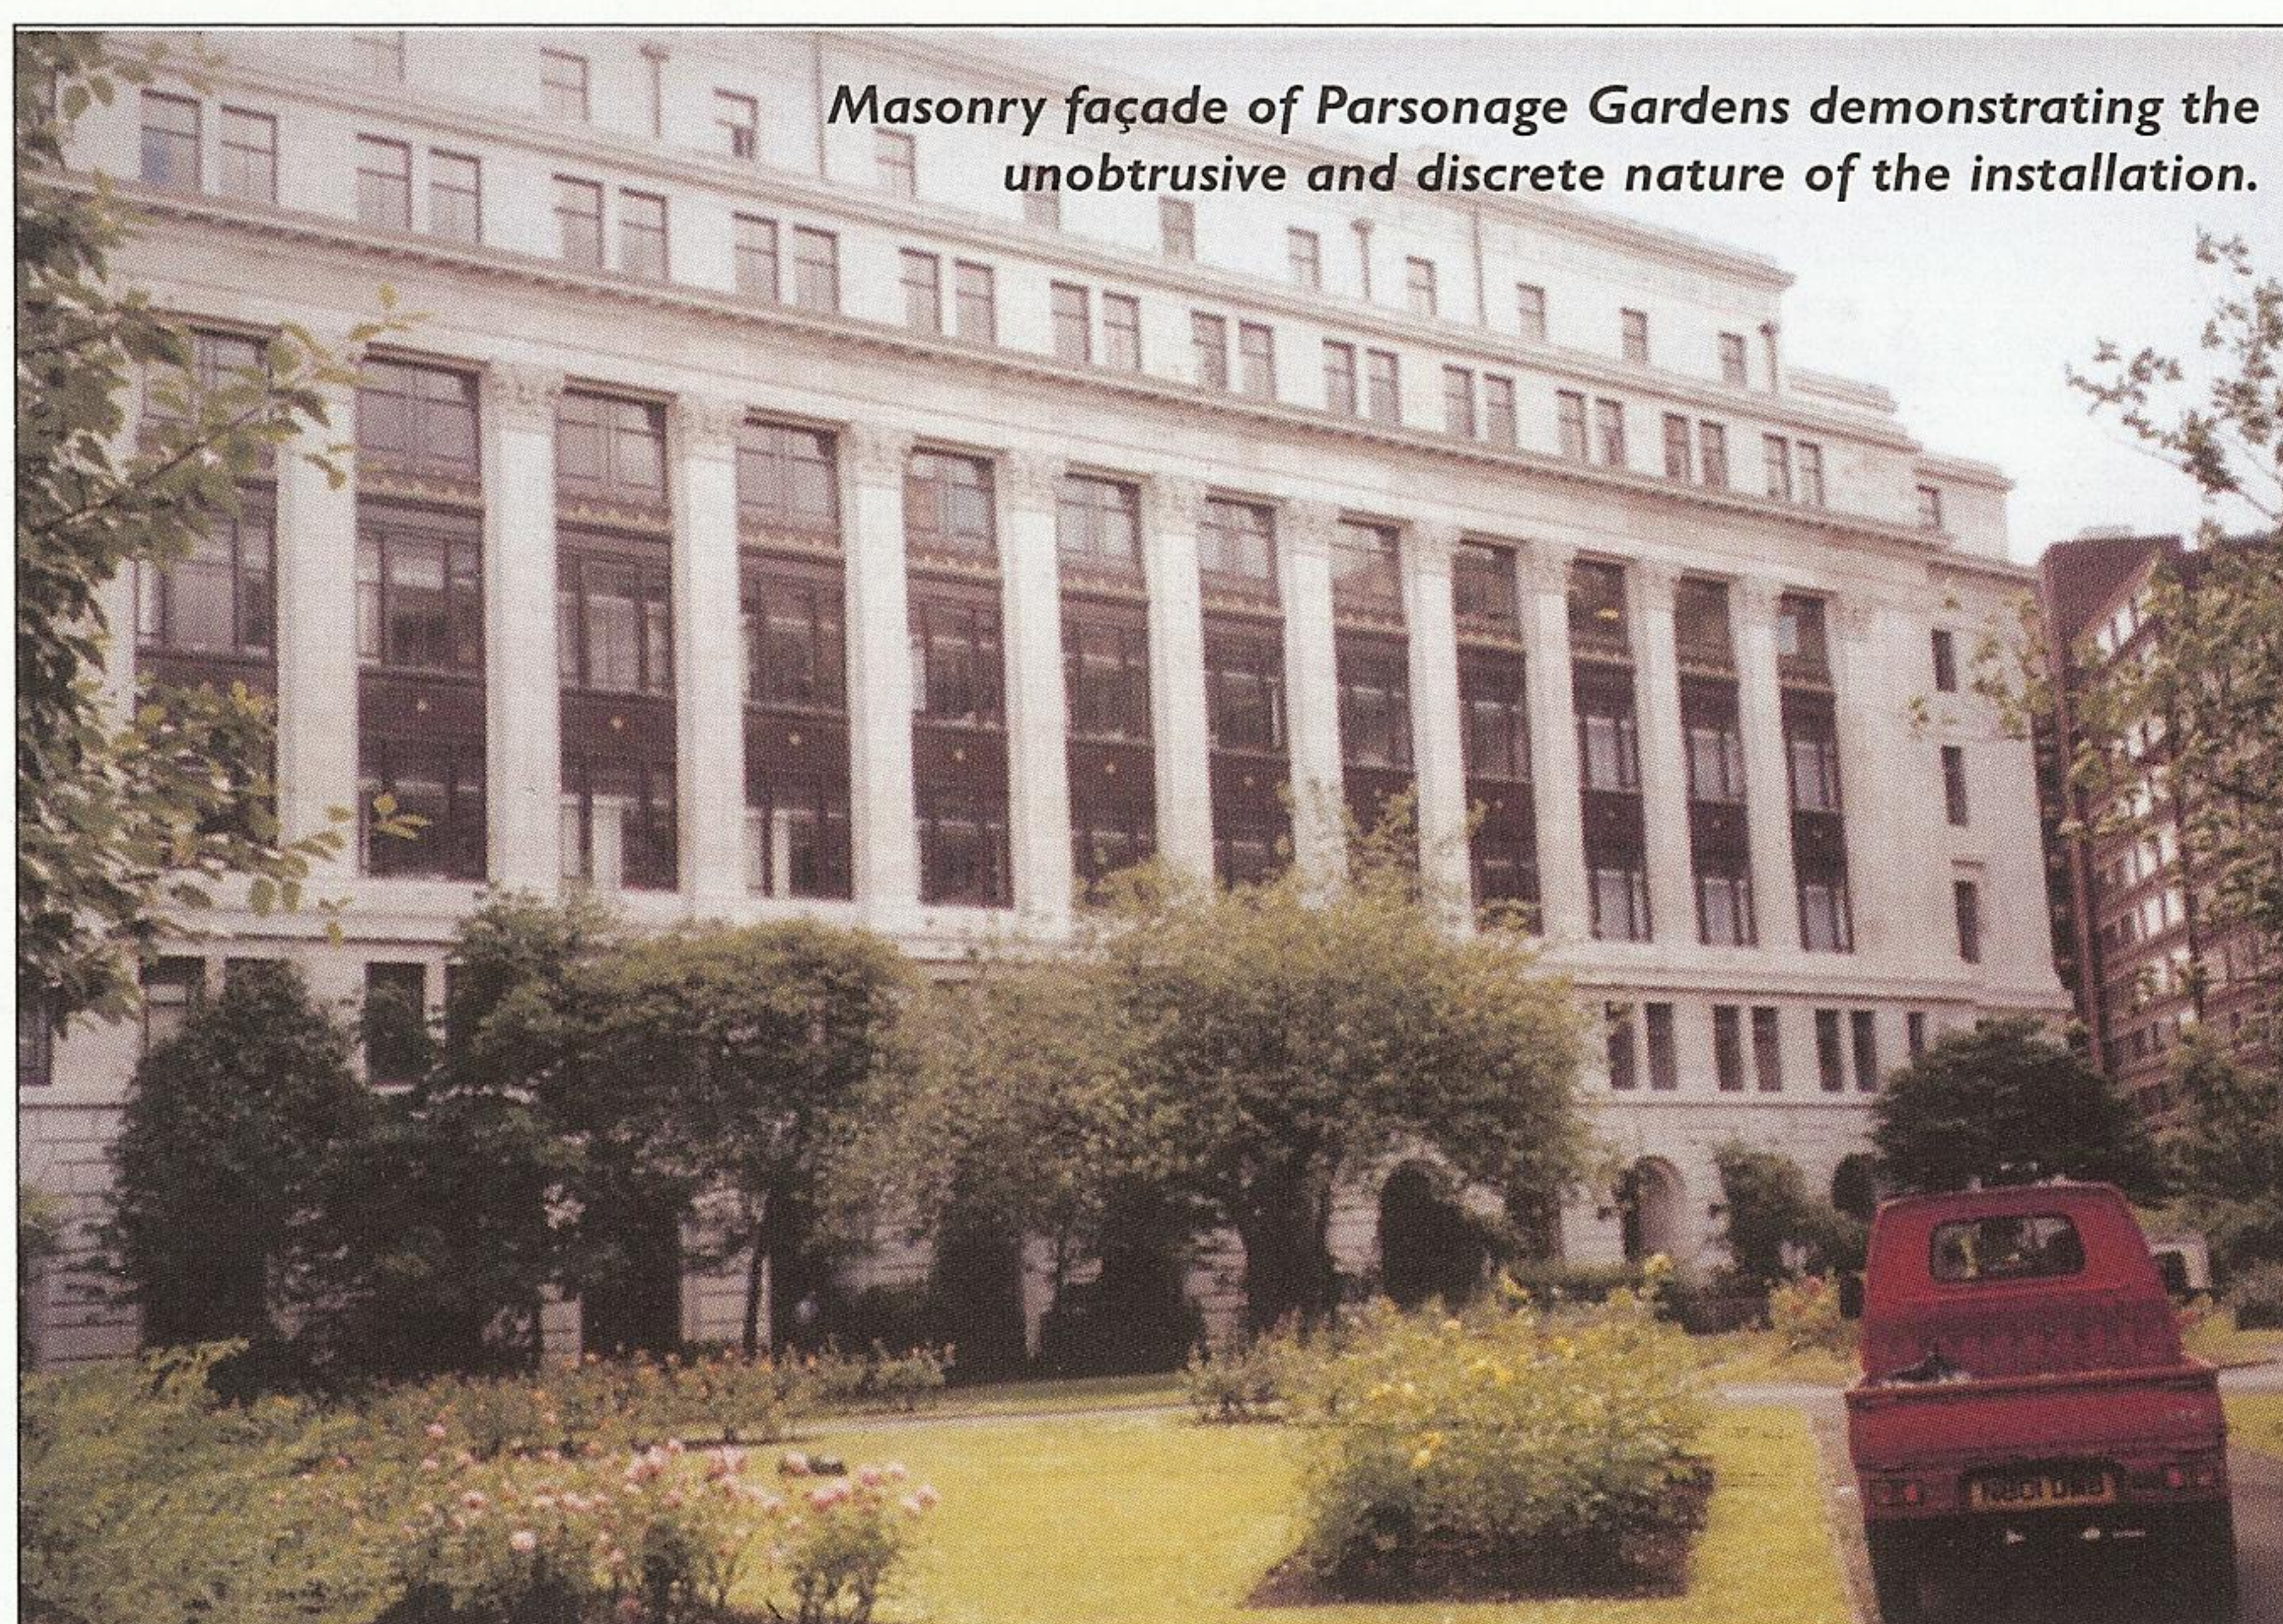
Masonry façade of Parsonage Gardens demonstrating the unobtrusive and discrete nature of the installation.

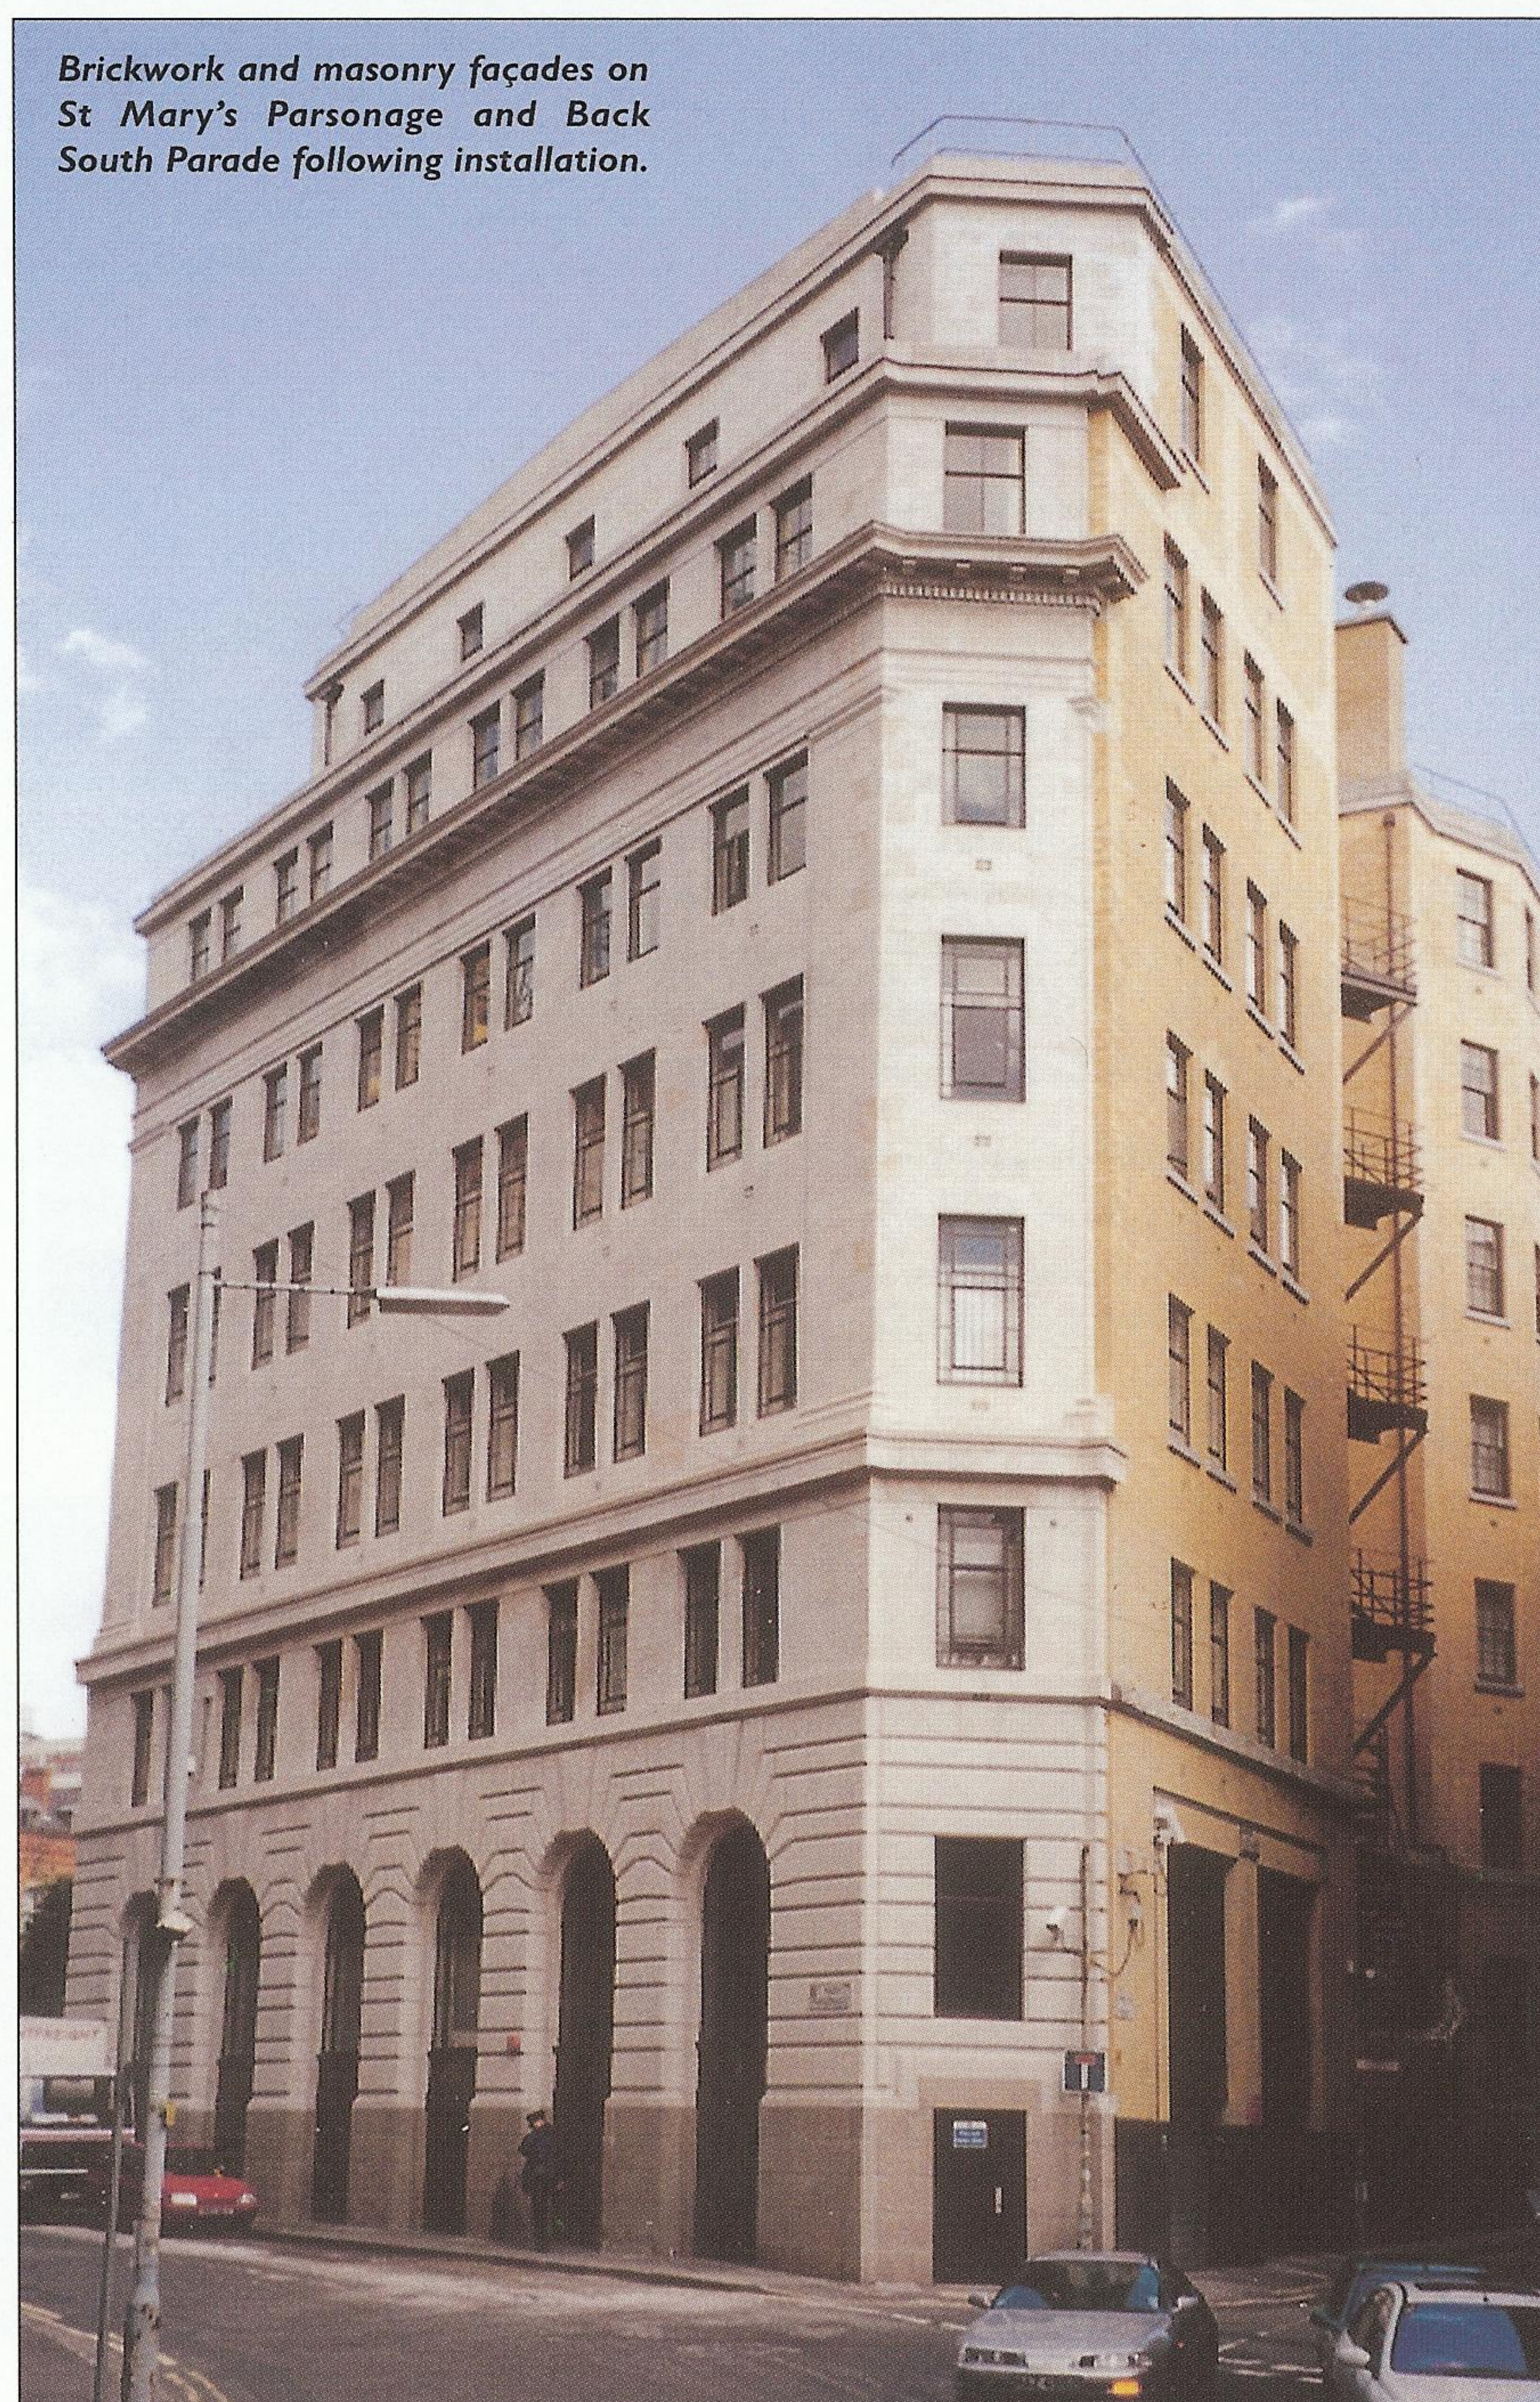
Brickwork and masonry façades on St Mary's Parsonage and Back South Parade following installation.
