LONGFELLOW TOWERS 1 AND 4

Boston, MA

Abstract

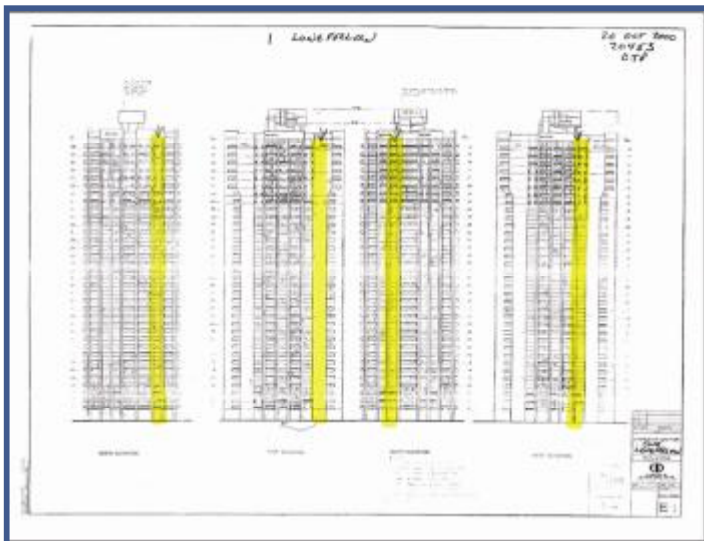
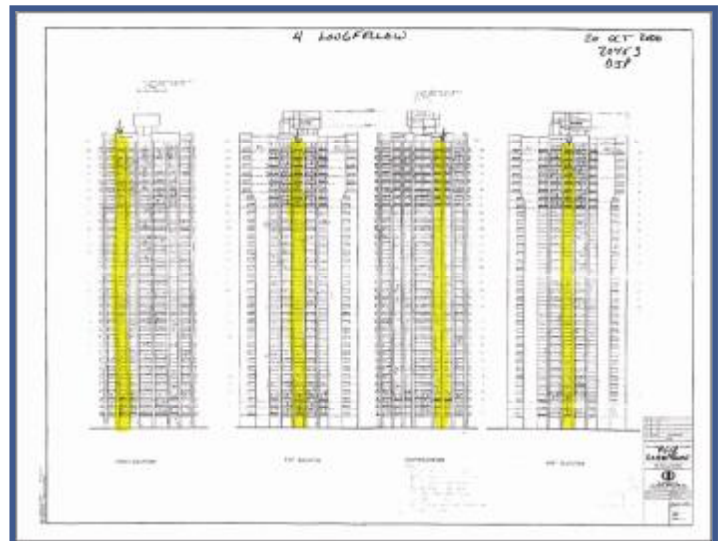
Visual and Sounding Survey by tapping with a hammer and visual observation.

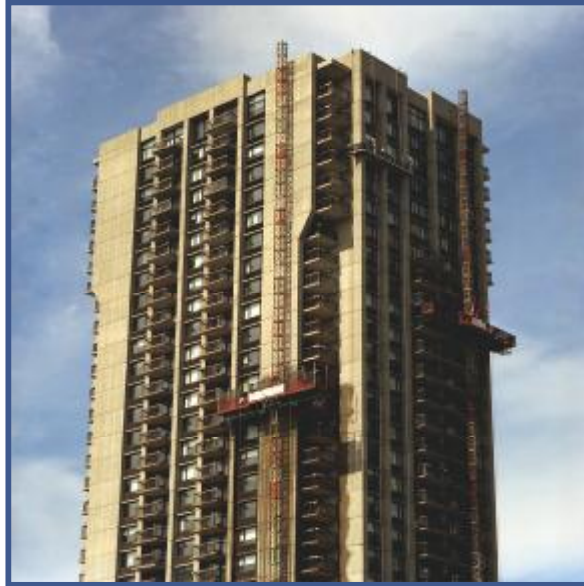
The combination of the need to access 100% of the building exterior surfaces from the outside and the configuration of the panels and balconies; particularly, toward the top of the buildings would require 20 drops in total or 10 drops per building. To accomplish this, the contractor used mast climbers on 16 drops and a swing stage on 4 drops.

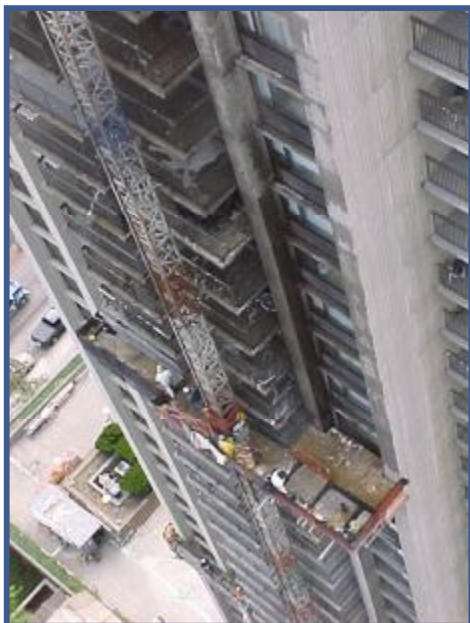
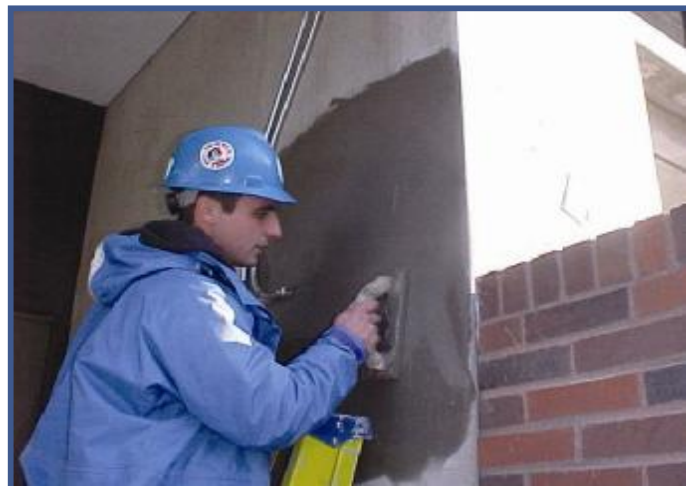
The steel coating and substrate primer was applied by a brush just prior to the repair reinstatement. The same repair material was hand applied for all horizontal, vertical and overhead repairs. The sealant was gunned out and tooled to the proper width:thickness ratio. The corrosion inhibitor was roller applied to the proper consumption requirements in two applications. Last, two coats of the elastomeric coating was applied by roller to the proper thickness.
