Hunterston Nuclear Power Station, Ayrshire

Corrosion Management System to the Cooling Water Intake Jetty and Headworks 'B'

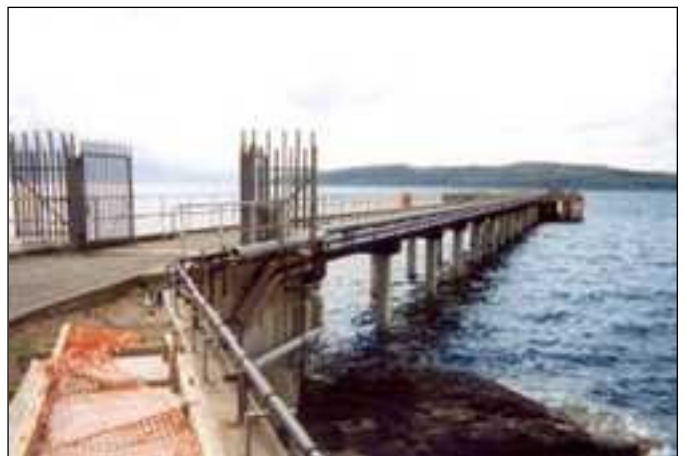
The jetty is exposed to extreme marine conditions and therefore required a durable protection system to ensure long life. To this end a mixed metal oxide (MMO) titanium anode mesh and cementitious overlay was installed to all concrete surfaces underneath the jetty including the intake shaft as well as above deck. MMO titanium ribbon was slotted into the columns. Below the water line zinc sacrificial anodes were installed.
